ControlLogix Standard Redundancy Firmware, Revision 16.057_kit1

Redundancy Module Catalog Numbers

1756-RM2, 1756-RM2XT, 1756-RM, 1757-SRM

About This Publication

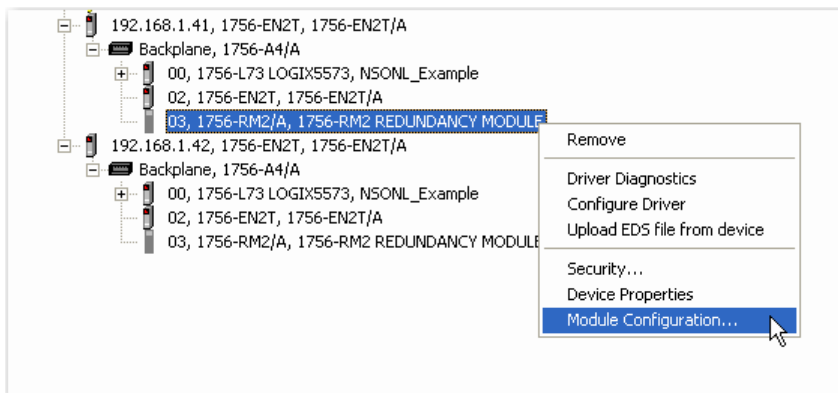
3. Right-click your redundancy module and choose Module Configuration.

The Module Configuration dialog box opens.

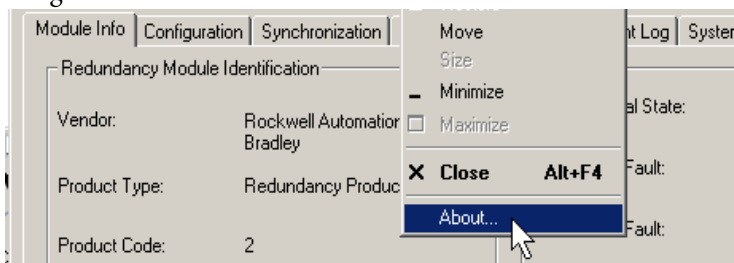
4. Right-click the title bar and choose About.

The About dialog box opens and indicates the RMCT version.

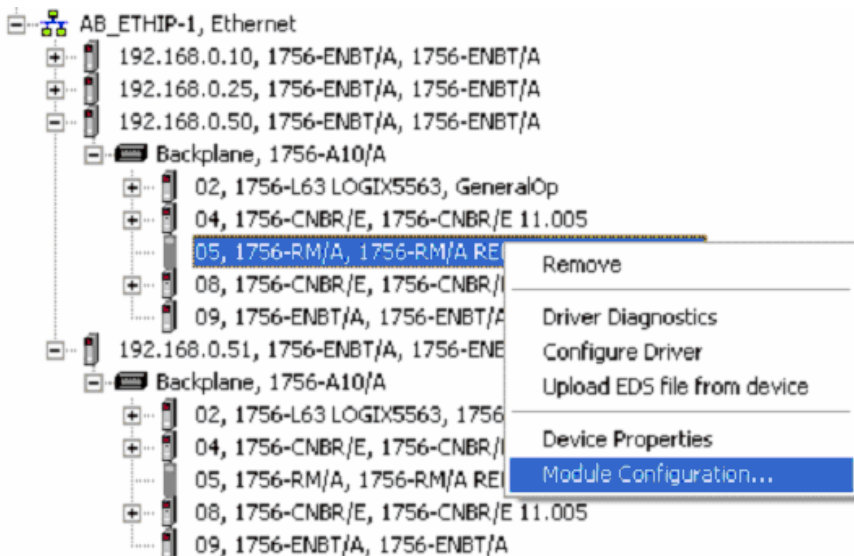
3. Right-click the redundancy module and choose Module Configuration.

4. Click the Configuration tab.

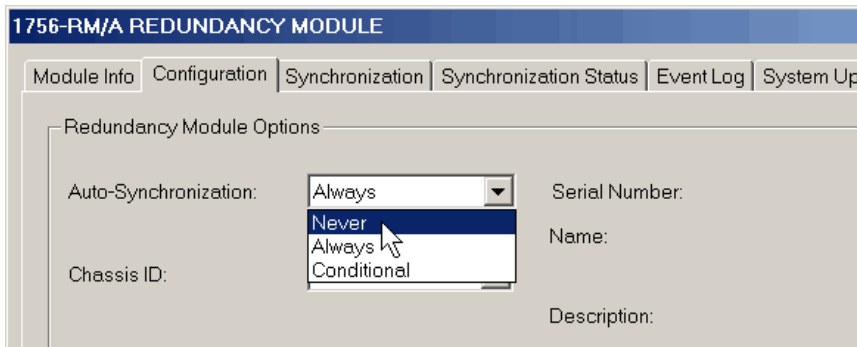
5. From the Auto-Synchronization pull-down menu, choose Never.

6. Click Apply, then click Yes.

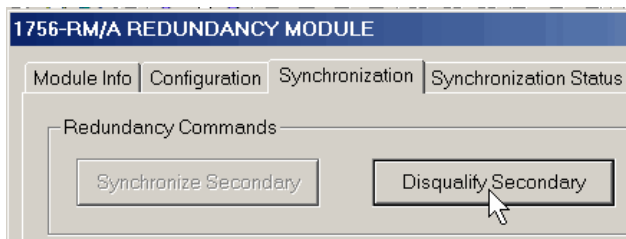
7. Click the Synchronization tab.

8. Click Disqualify Secondary, then click Yes.

The secondary chassis is disqualified as indicated at the bottom-left of the RMCT and on the redundancy module's status display.

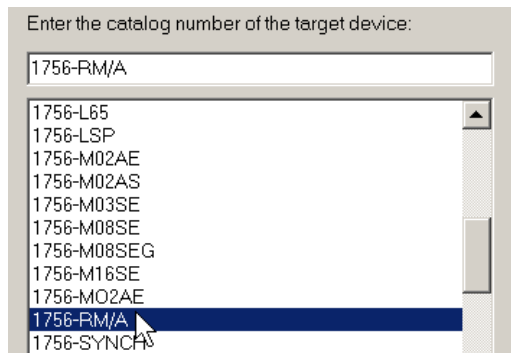
1. Launch ControlFlash software and click Next.
2. Select the redundancy module catalog number and click Next.

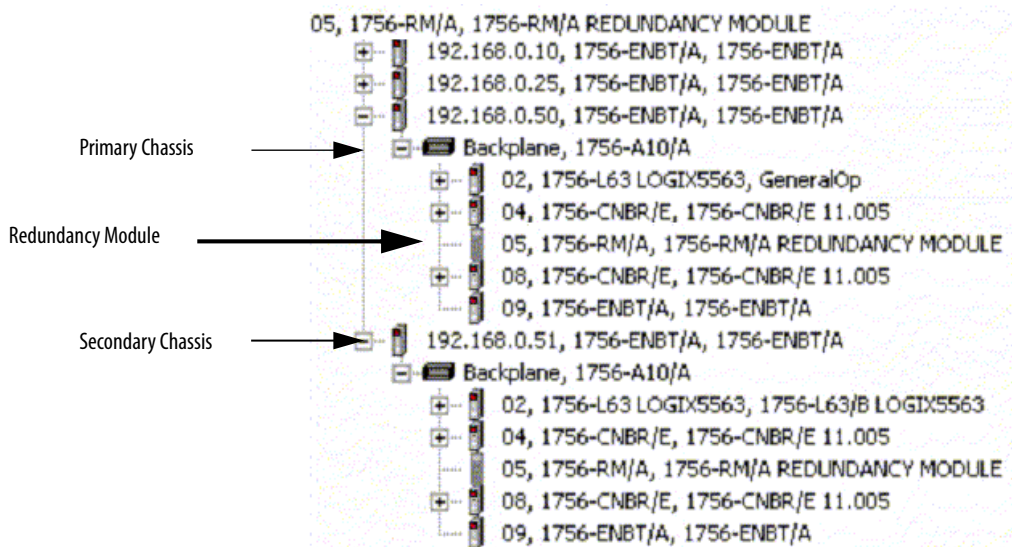
3. Browse to the redundancy module and select it.

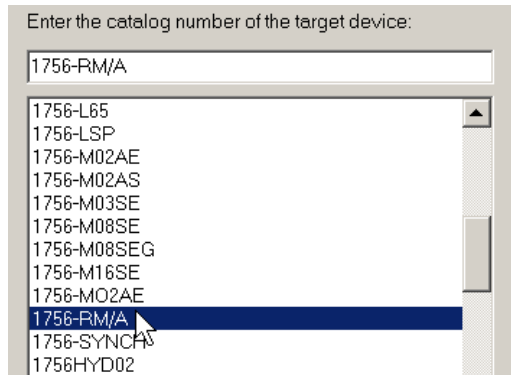
2. Select the redundancy module catalog number and click Next.

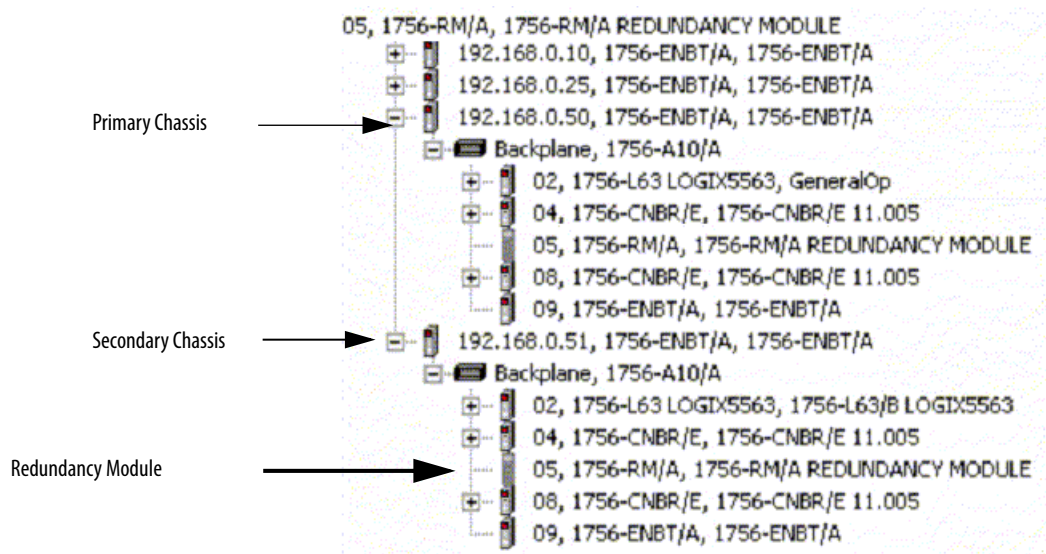
3. Browse to the redundancy module and select it.

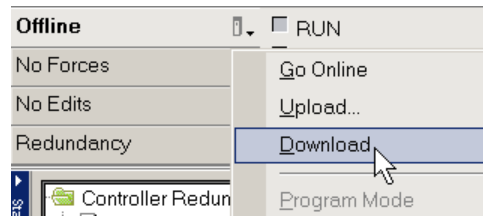
15. Download the project to the secondary controller.

The secondary controller is at the higher network address of the two available for the redundant chassis.

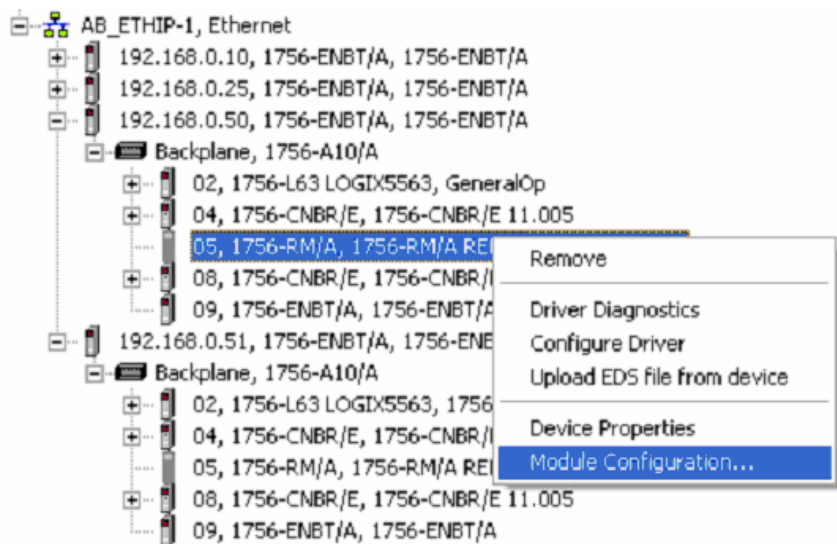
1. Open the RMCT for the 1756-RM module in the primary chassis.

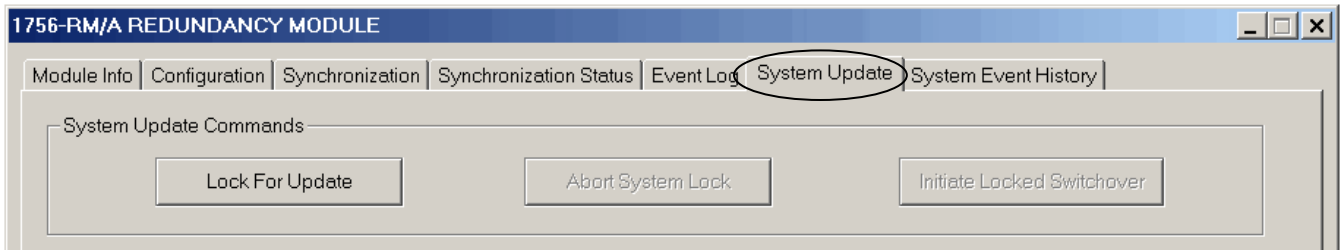
- Click the System Update tab.

- Click Lock for Update, then click Yes.
- Wait for the system to lock.

The System Update Lock Attempts log indicates when the system lock is complete.

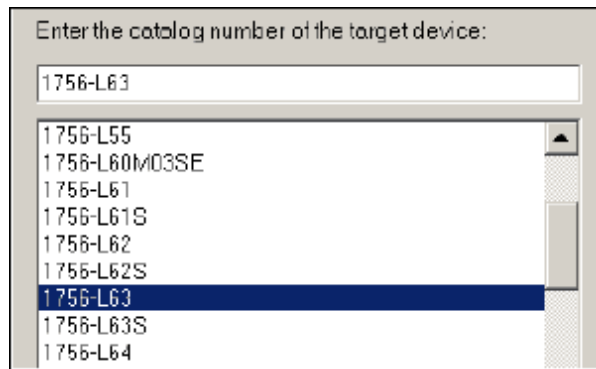
1. Launch ControlFlash software and click Next.
2. Select the module catalog number and click Next.

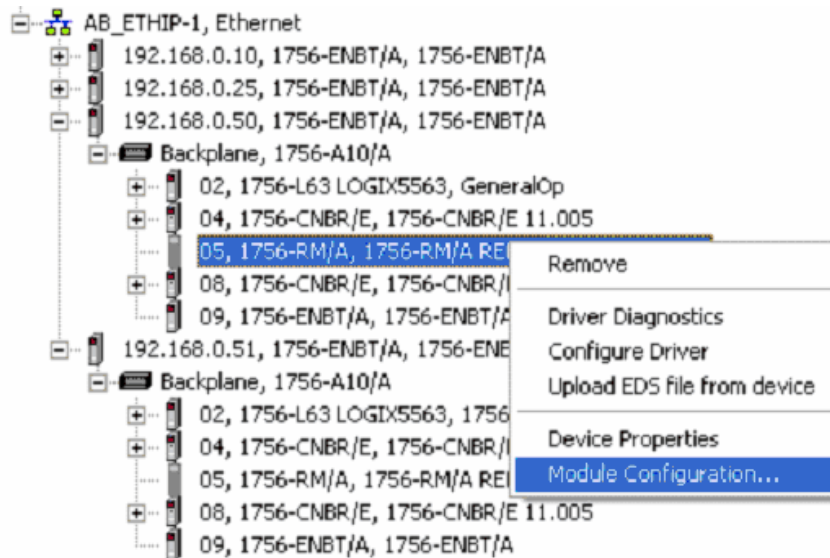
1. Launch the RMCT for the 1756-RM module in the primary chassis.

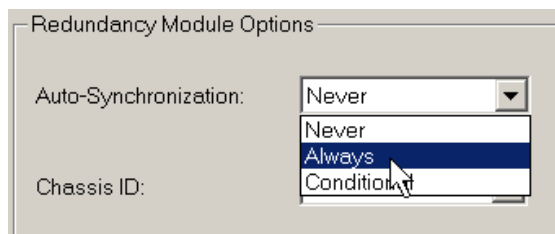
2. Click the Configuration tab.
3. From the Auto-Synchronization pull-down menu, choose the frequency that suits your application.

4. Click Apply, then click Yes.
5. Set the redundancy module date and time according to your preference.
6. Click OK.
7. Close the RMCT.

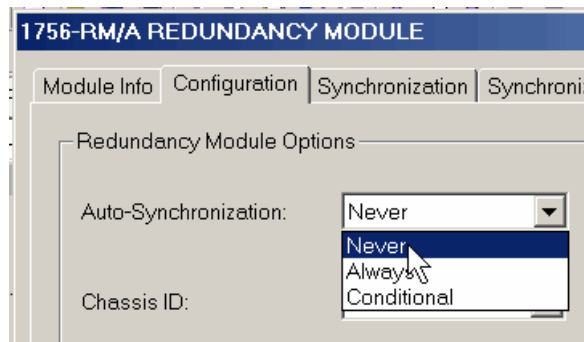
2. In the RMCT, click the Configuration tab and from the Auto-Synchronization pull-down menu, choose Never.

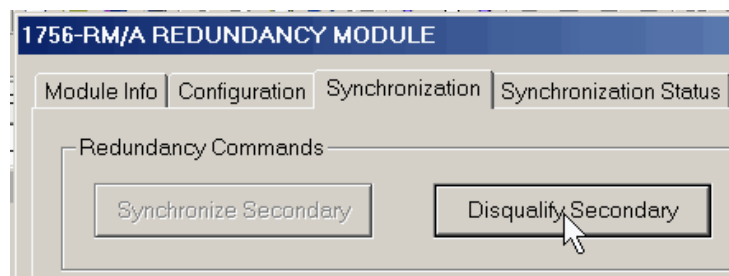
3. In the Synchronization tab, click Disqualify Secondary.

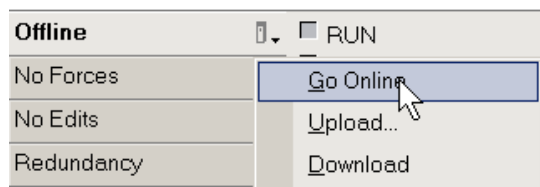
4. In RSLogix 5000 programming software, go online with the secondary controller.

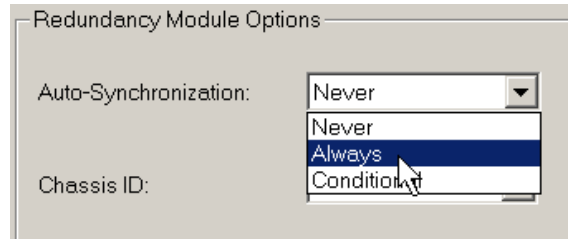
- In the RMCT, set the Auto-Synchronization parameter according to your preference.
