DX200 MAINTENANCE MANUAL

Part Number: 165293-1CD
Revision: 6

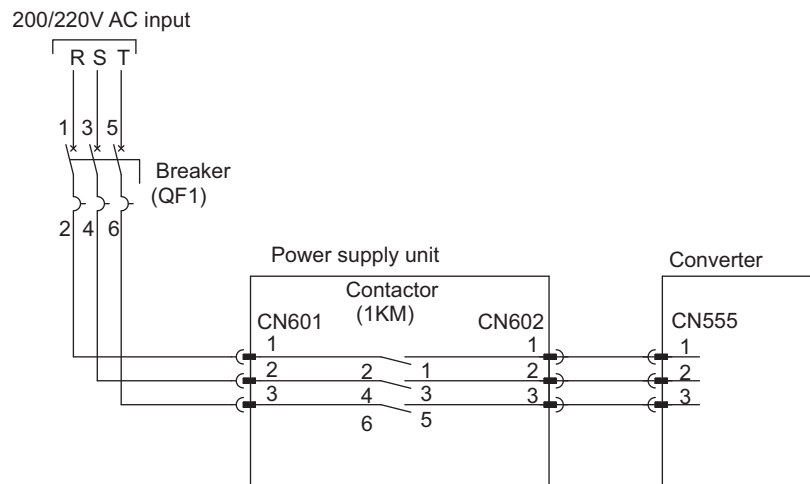
Check Item	Contents
Lead Cable Check	Confirm if the lead cable for the power supply is wired as shown in the following without any falling out, looseness or breaking from the connecting part.
Input Power Supply Check	Check the open phase voltage of input power supply with an electric tester. (Normal value: 200-220V _{AC} (+10%, -15%))
Circuit Breaker (QF1) Check	Turn ON the breaker and check the open phase voltage of "2, 4, 6" of the circuit breaker (QF1) with an electric tester. If abnormal, replace the circuit breaker (QF1).

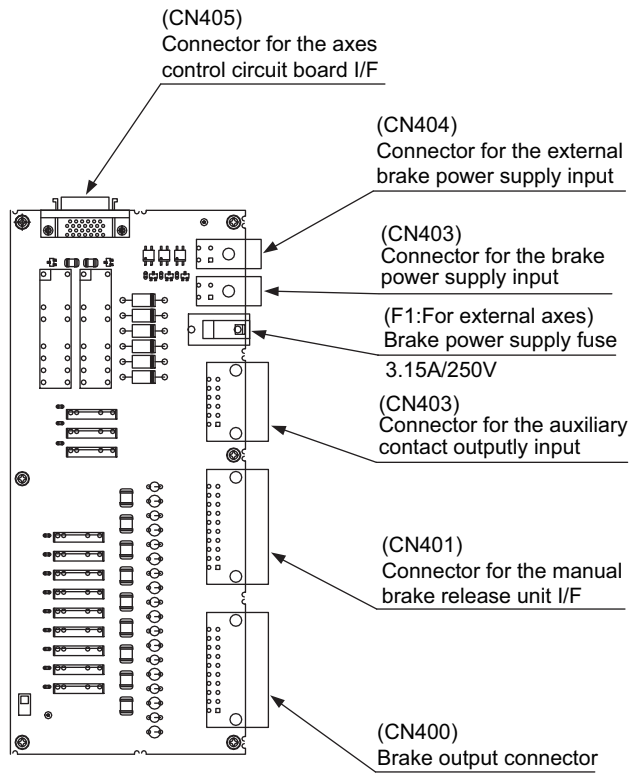
Fig. 5-8: Brake Circuit Board (JANCD-YBK21-3E)

11. Remove the jumper wiring connector from the old brake circuit board, and reinstall it to the new brake circuit board.
12. Reinstall the other removed cables, screws and the cover as follow the Procedure from step 7. to 3.

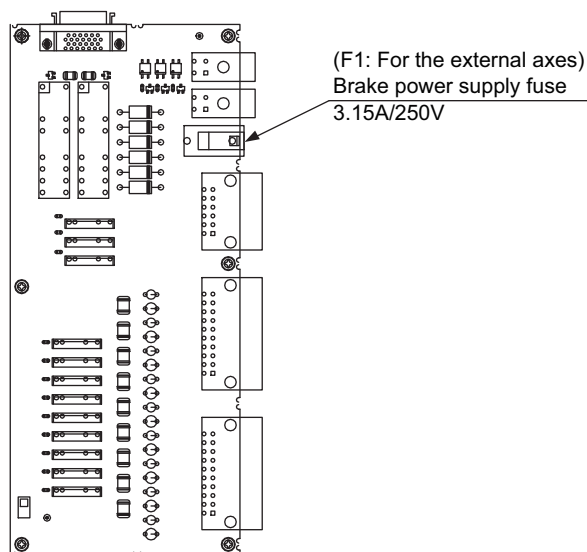
Fig. 5-19: Brake Circuit Board (JANCD-YBK21-3E)

Parts No.	Fuse Name	Specification
F1	Brake power supply fuse for the external axis	02173.15P, 250V,3.15A, Rapid cut fuse (LITTEL)

If the fuse is blown, replace it with the same type of fuse (supplied or spare parts).

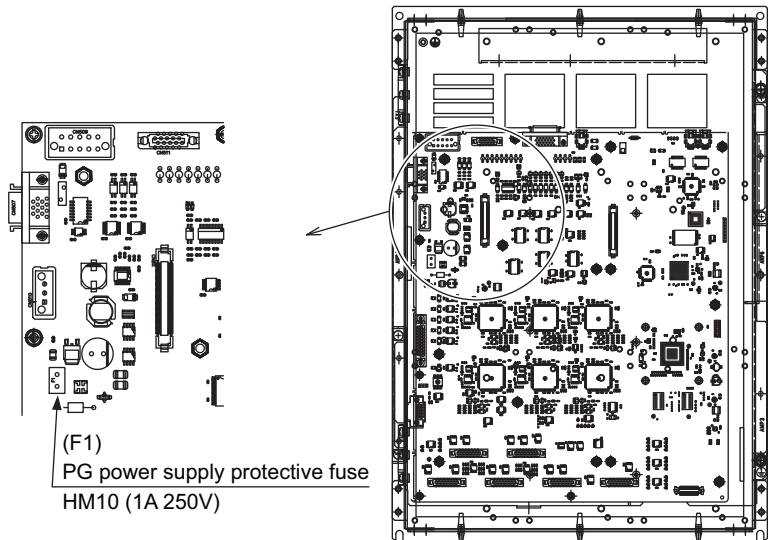
Fig. 5-20: Replacement Fuse of the Major Axes Control Circuit Board (SRDA-EAXA21A)

Parts No.	Name	Specification
F1	PG power supply protective fuse	HM10 250V, 1A Daito Communication Apparatus Co.,Ltd

If the fuse is blown, replace it with the same type of fuse (supplied or spare parts).

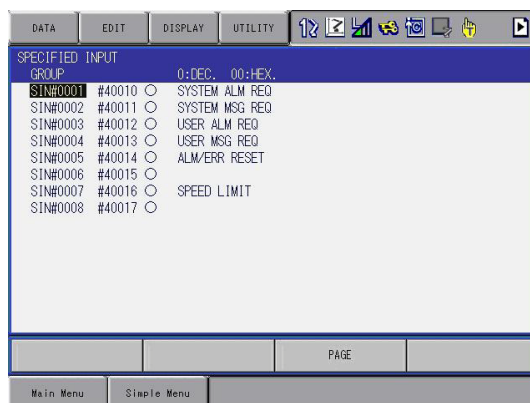
7.3.3.1 Specific Input Window

1. Select {IN/OUT} under the main menu.
2. Select {SPECIFIC INPUT}.
 - The SPECIFIED INPUT window appears.

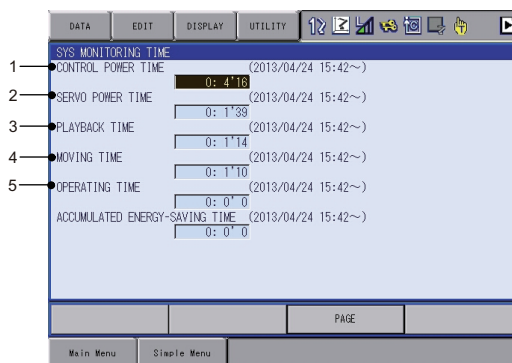
7.4.1 System Monitoring Time Display Window

The status of system operation, e.g. power ON time, can be checked.

1. Select {SYSTEM INFO}.
2. Select {MONITORING TIME}.
 - The SYS MONITORING TIME window appears.

1, CONTROL POWER TIME

Displays the cumulative time that the main power supply has been ON.

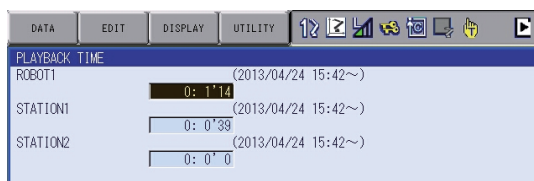
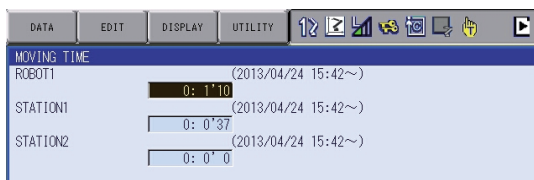
7.4.2 Individual Window of the System Monitoring Time Display

If the [PAGE] key is pressed, or "PAGE" is selected to display the selection window for the system monitoring time display, the servo power time, playback time, moving time, and each-application operating time by each control group are individually displayed.

The total time of each control group here is not always the same as the time in the SYS MONITORING TIME window because these windows show time as seen from the individual control group.

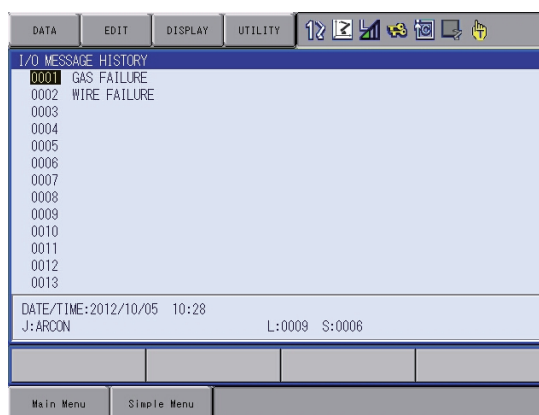
The I/O MESSAGE HISTORY window shows the date and time, job name, line number, and step number of the I/O message that appeared on the window.

1. Select {SYSTEM INFO} under the main menu.
2. Select {I/O MSG HISTORY}
 - The I/O MESSAGE HISTORY window appears.

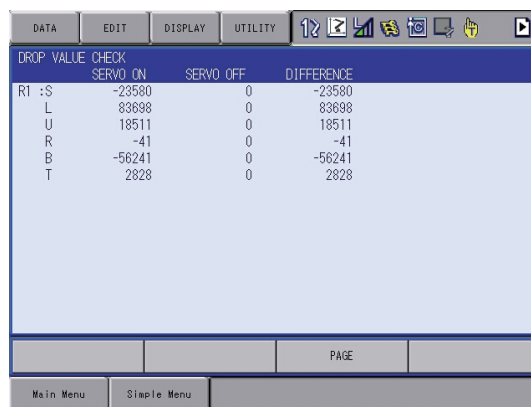
The position value of the manipulator where the servo was turned off (shown as SERVO ON on the screen), the position value of the manipulator where the servo is turned on (shown as SERVO OFF on the screen), and the difference value from these positions above are displayed in this window.

2. Select {DROP VALUE CHECK}.
 - The DROP VALUE CHECK window appears.
